# Manhole Inspection Summary

Manhole # S23CC1016MH

**Location** Address: **3600 CLIPPER MILL RD**

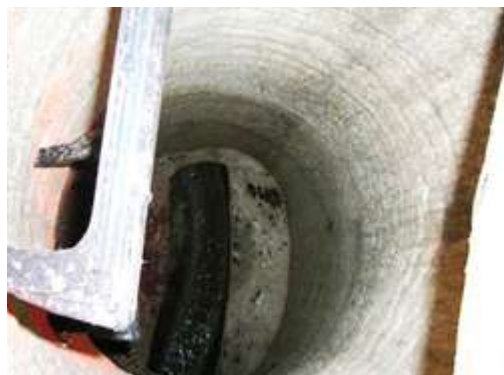
Top View

Infiltration: ☐ None ☒ **Joint** ☐ Cracks ☐ Mortar ☐ Roots ☒ **Wall**

Infiltration: ☐ None ☐ Joint ☐ Cracks ☐ Mortar ☐ Roots ☒ **Wall**

**Bench** ☒ Exists Material: **Unknown** ☐ Parged ☒ **Debris** (not Condition related)

Adjustment and Barrel infiltration. Bench debris.

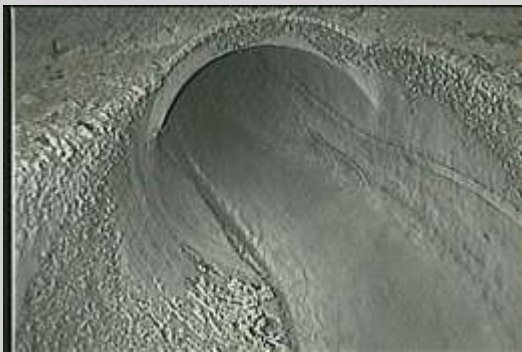
### 18 in. Circular Gravity Sewer Pipe Out @ 12 O'Clock

Pipe Material: **Unknown** ☒ Pipe Lined

Invert Depth: **13.84** (ft.) Flow Characteristics: **Fast**

Deposits: ☒ None ☐ Mud ☐ Sludge ☐ Debris ☐ Grease

Infiltration: **None** Pipe Seal Cond: **Unknown**

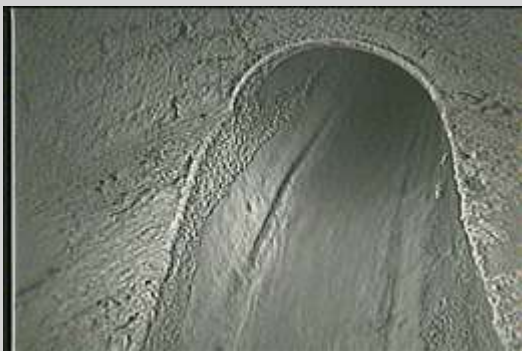
### 18 in. Circular Gravity Sewer Pipe In @ 7 O'Clock

Pipe Material: **Unknown** ☒ Pipe Lined

Invert Depth: **13.15** (ft.) Flow Characteristics: **Fast**

Deposits: ☒ None ☐ Mud ☐ Sludge ☐ Debris ☐ Grease

Infiltration: **None** Pipe Seal Cond: **Unknown**
